Slotted Corrugated Metal Pipe Drains

# HIGHWAY RESEARCH REPORT

## SLOTTED CORRUGATED METAL PIPE DRAINS

**NO. M & R 636453**

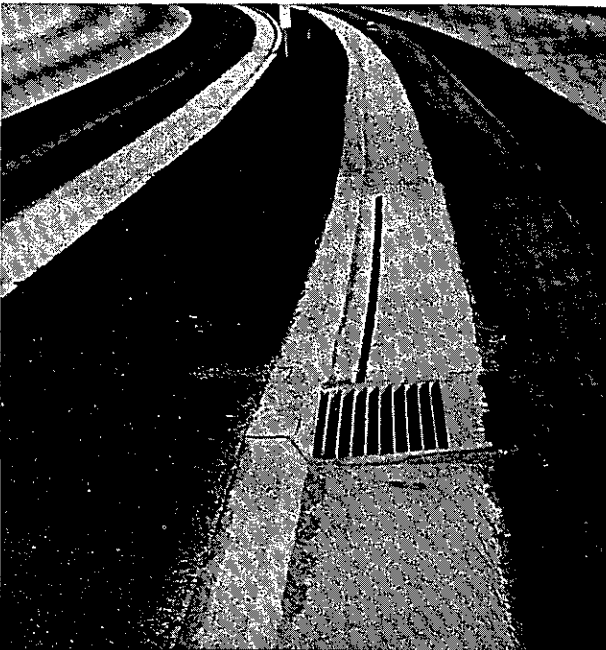
FIGURE 6

SLOTTED DRAINS SUPPLEMENTING OTHER DRAINAGE INLETS

Several other applications of the slotted drain pipe that have been observed recently are presented in Figures 6 and 7.

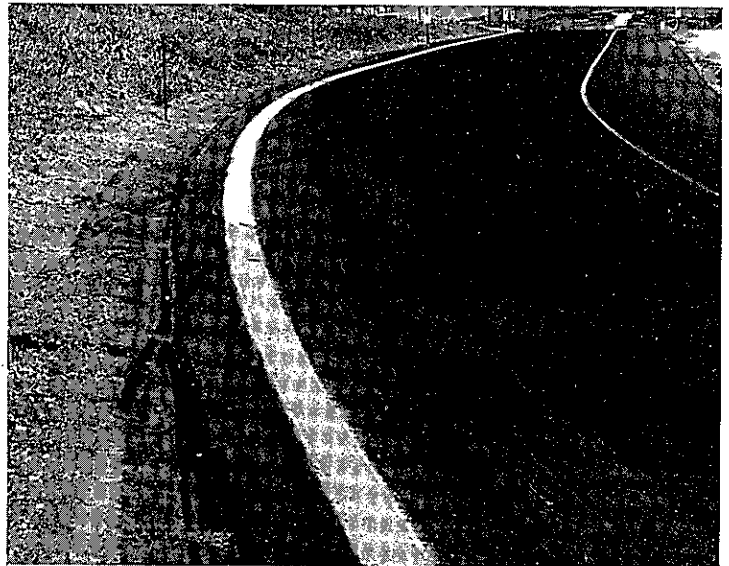
FIGURE 7

SLOTTED DRAIN WITHOUT DIKES OR CURBS

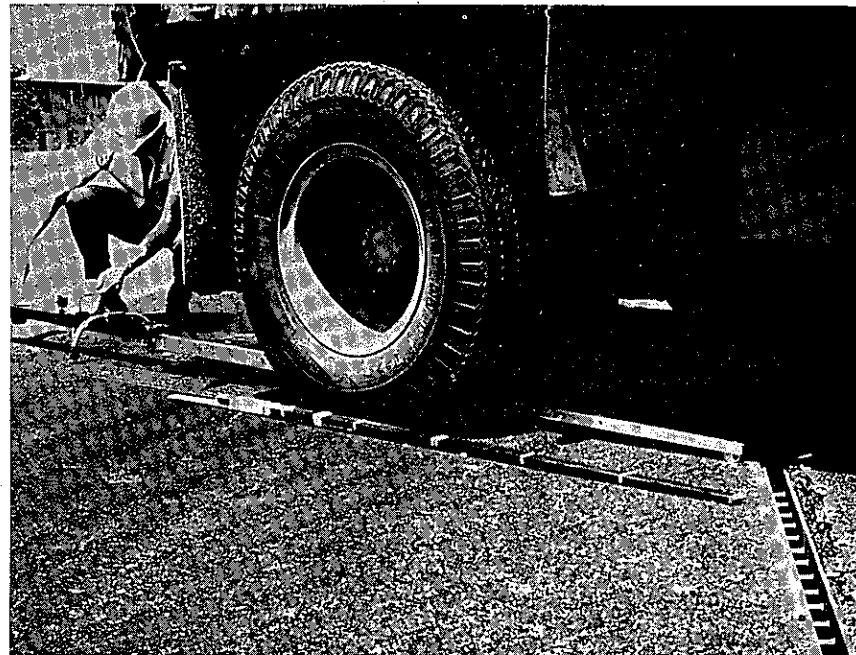
FIGURE 8

DEFLECTION MEASUREMENTS ON 07-ORA-55  
WITH THE BENKELMAN BEAM

Deflections were measured at several distances from the slot to determine the critical load location for pipe deflection. As expected, the maximum deflections were measured with the wheel load at or near the pipe slot. The maximum pipe deflection was 0.093 inch.

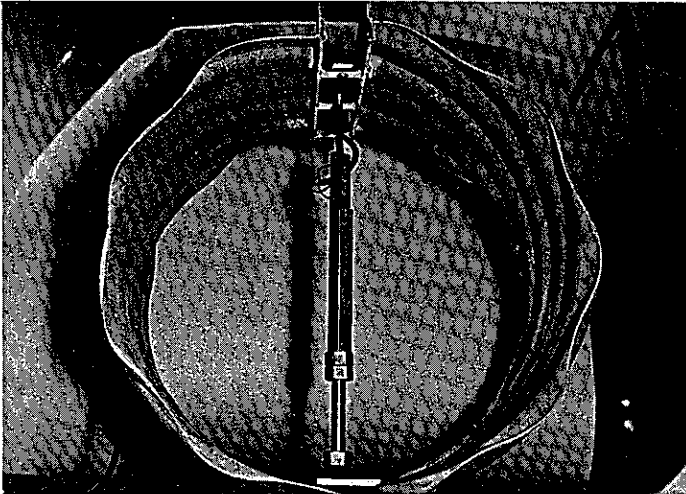
FIGURE 9

INTERNAL  
INSTRUMENTATION  
IN PLACE

EQUIPMENT INCLUDING  
TRANSDUCER/STRAIN  
INDICATOR

Considerable difficulty was encountered in positioning the beam-wheel load combination in the vicinity of the slot. Therefore, to perform the remaining investigations, deflection measuring equipment was designed to fit inside the slotted drain pipe. This eliminated the chance of probe damage by the truck tires and, also, provided a greater confidence in the deflection reading by reducing the chance of the probe slipping during the loading. The testing apparatus is shown in Figure 9.

This internal measuring device consists of a linear potentiometer capable of accommodating movements to 1.3 inches. The potentiometer was calibrated with a transducer/strain indicator to provide vertical movements in mils (one thousandth of an inch). The potentiometer was supported from the base by an adjustable leg that accommodated variations in pipe shape or diameter. An initial reference for each set of readings was obtained by an

adjustable set screw in the grate clamp assembly. Movements between the grate or pavement surface and the pipe invert were measured.

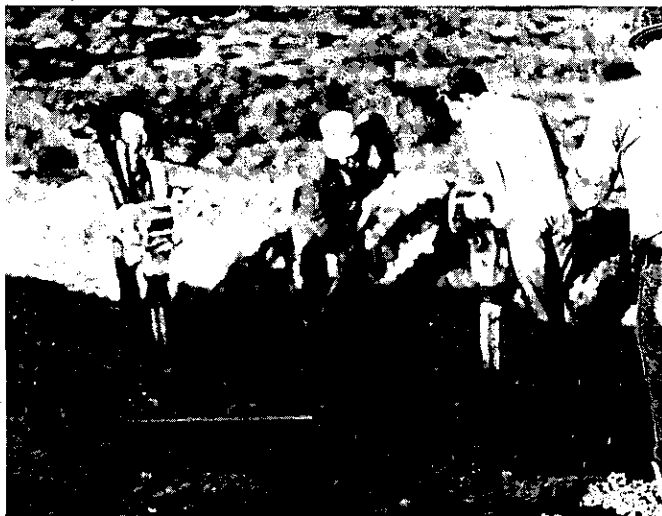
FIGURE 11

BACKFILL COMPACTION ON SLOTTED DRAIN PIPE FOR  
11-SD-805-3.5/7.3

Material from the trench excavation was used as pipe backfill on the 11-SD-805-3.5/7.3 project. This material was a sandy embankment soil combined with some Class 4 aggregate subbase and Class 2 aggregate base. Location #1 utilizing Design Alternate 1 was an exception to this as the structural section consisted of 0.50' CTB over the aggregate subbase in the shoulder. The backfill material around the drain pipe was compacted with two Master T-1000 portable compactors as shown in Figure 11. These installations were made with normal construction procedures, inspection, and controls.

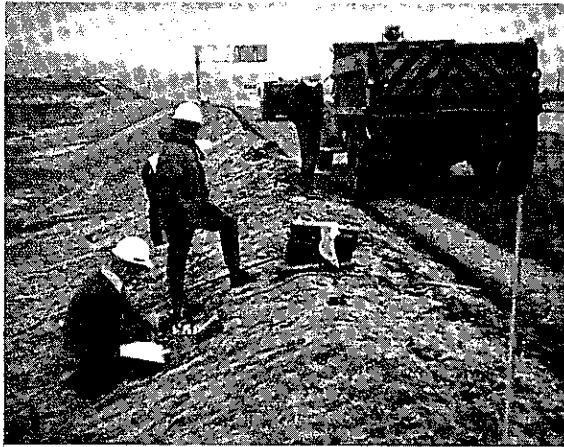
FIGURE 12

DEFLECTION MEASUREMENTS ON  
11-SD-805  
WITH INTERNAL INSTRUMENTATION

DEFLECTION APPARATUS  
IN PLACE

The asphalt concrete in the shoulder areas at all three locations on Route 11-SD-805-3.5/7.3 had a 0.25' design thickness and was placed about one week prior to the deflection measurements which were made with the internal pipe deflection measuring instruments as shown in Figure 12.

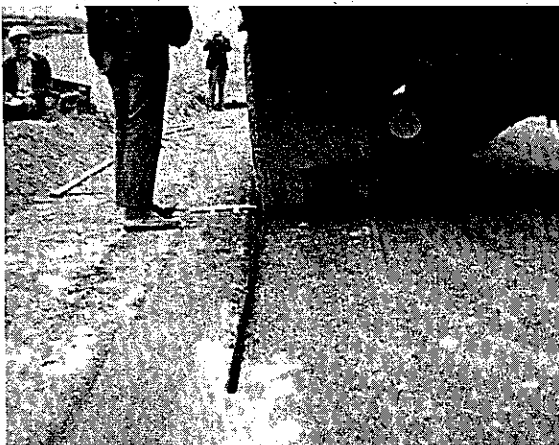
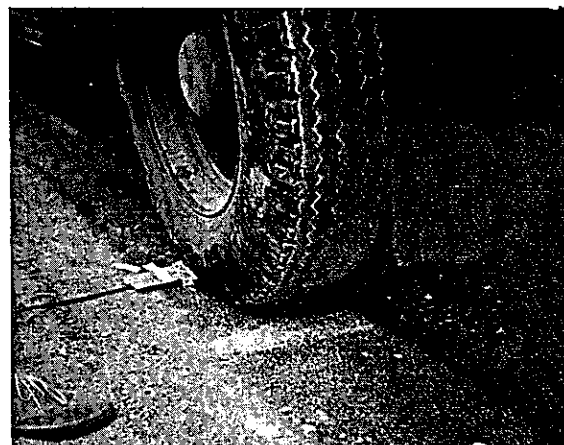
FIGURE 14

LOAD ORIENTATIONS AS APPLIED TO THE SLOTTED DRAIN PIPE

(a) Load 10" from center line.

(b) Load on center line.

Internal deflection measurements were made on all of the slotted drain pipe installations investigated except for the initial measurements on the project on Route 07-0ra-55. The Benkelman Beam was used for measuring deflections of slotted drain pipe under a 12.3 Kip single axle load on project 07-0ra-55 and also for determining the deflections of shoulders and the deflection of standard corrugated metal pipe on the projects on Route 11-SD-805. Deflection measurements were taken on the Route 11-SD-805 projects with the center of the dual straddled over the slot. These positions are shown pictorially in Figures 14a and 14b.

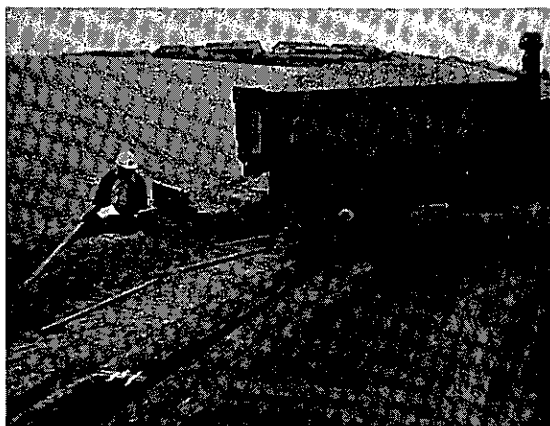
FIGURE 15

LOAD PERPENDICULAR TO SLOT

Additional tests were made on the Route 11-SD-805 projects at Locations 2 and 3 between P.M. 3.5/7.3 and at Location 4 at P.M. 17.1 with the wheel perpendicular to the slot as shown in Figure 15. This orientation placed all of the applied load directly on the pipe, and therefore resulted in greater pipe deflections. It was assumed that trucks using a flotation\* tire would apply a direct load to the pipe in a similar manner.
